# Forensic Evaluation of Masonry Materials Castle Pinckney, Charleston Harbor, SC

Denis A. Brosnan, Ph.D., P.E.  
Bishop Chaired Professor  
Clemson University  
© 2013, D. A. Brosnan

July 3, 2013

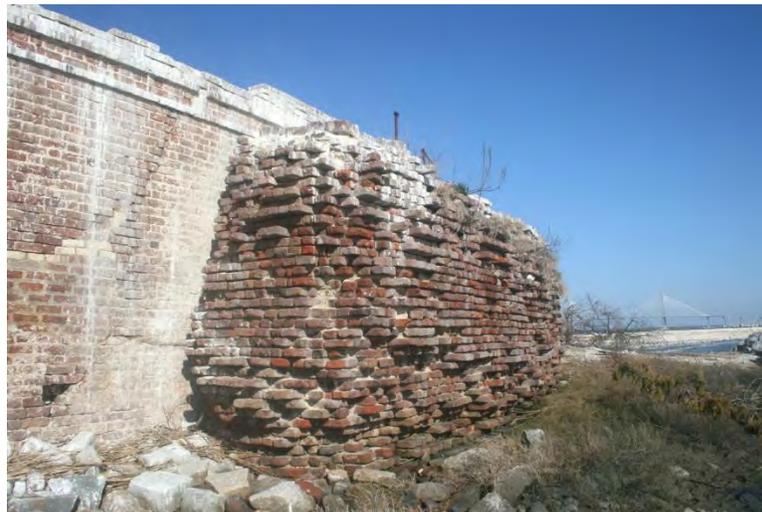
**Figure 5: Masonry Addition to North Wall**

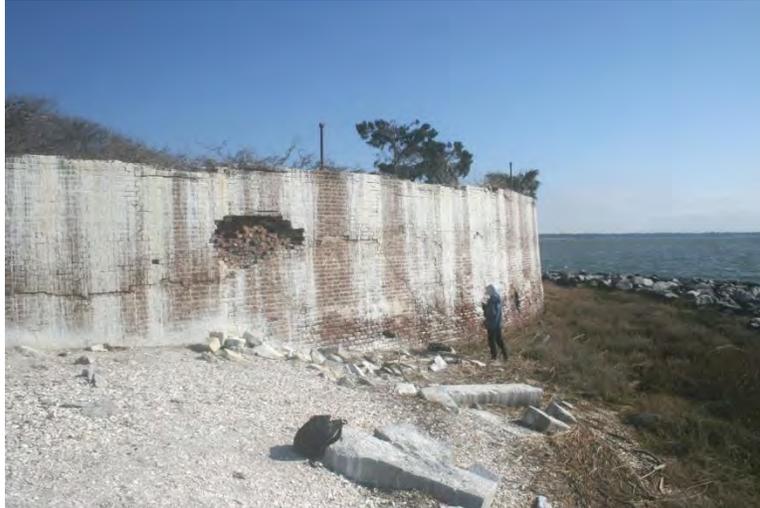
**Figure 8: Harbor Face from Southwest**

Weirick uses the term “brick patches” to presumably include the area of brick loss of Figure 8. This loss is more likely due to the structural phenomena discussed above where bricks simply fell out over time, as this phenomenon is seen on brick masonry buildings subject to a variety of stresses. Some actual “patches” were present to include lighthouse era repairs (Figures 15 and 16).

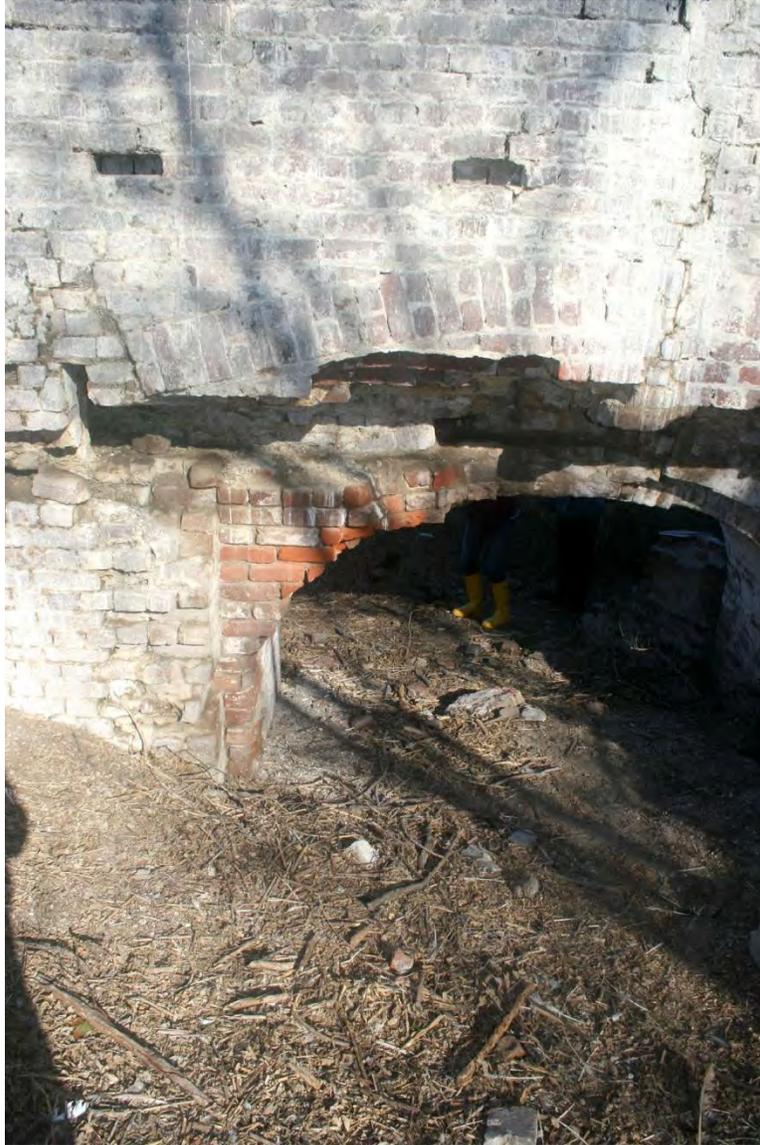
The interior earthen fill is obvious in Figure 12. It partially obscures the sally port which barely remains passable today due to the fill principally on the interior but also present on the exterior (Figure 7). There was apparently no obstruction of the exterior to the sally port in 1978 (Figure 13).

**Figure 12: Sally Port from the Castle's Interior**

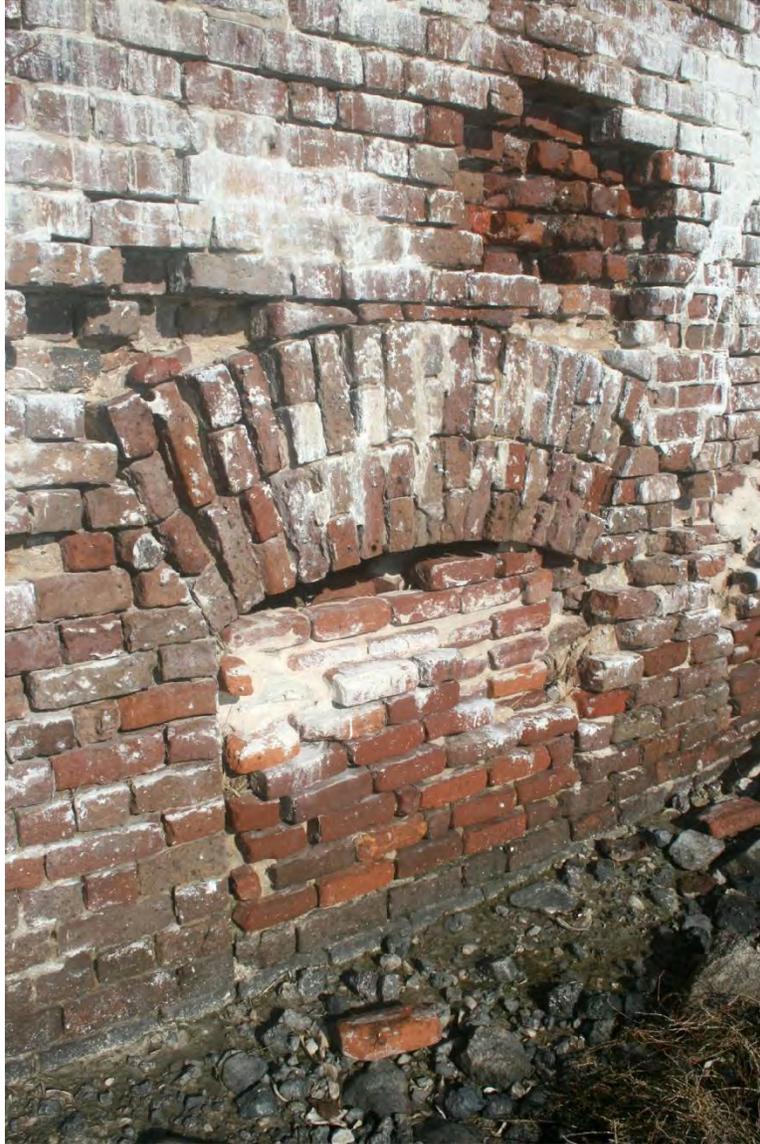
Lower level embrasures on the circular wall were closed with masonry (Figure 14) probably when the Confederates used the Castle as a prison. Lewis and Langhorn report that the casemates were disarmed in 1864 when the Confederates filled the interior with sand (reference 3). The base of the wall today is obviously damp due to sea water impingement.

**Figure 14: Embrasure on East Exterior Wall Closed with Masonry**

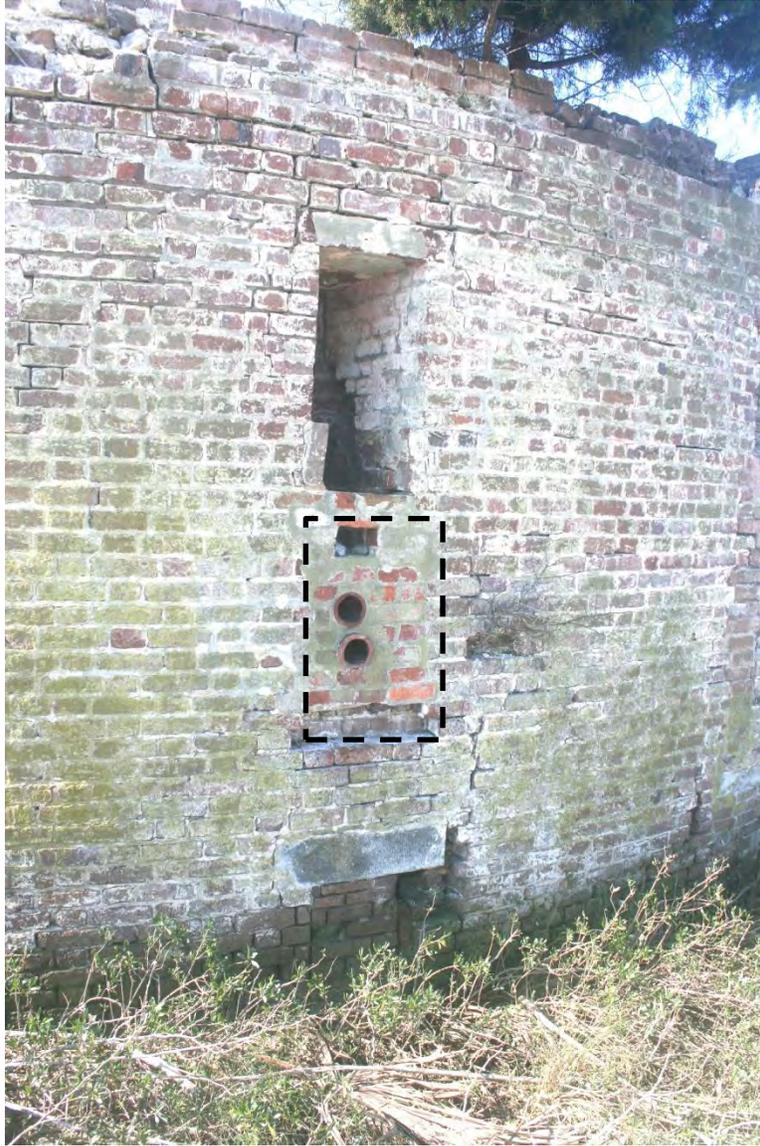
Specimens obtained for further study were from the East bastion midway in elevation between two embrasures (Figure 15). This was a location where two clay drainage pipes were installed after the Civil War and possibly during the days of lighthouse service. In the area of this repair (dashed box), the bricks are notably of a red color and the white coating is absent.

**Figure 15: Specimen Location above Partially Buried Embrasure; East Bastion**

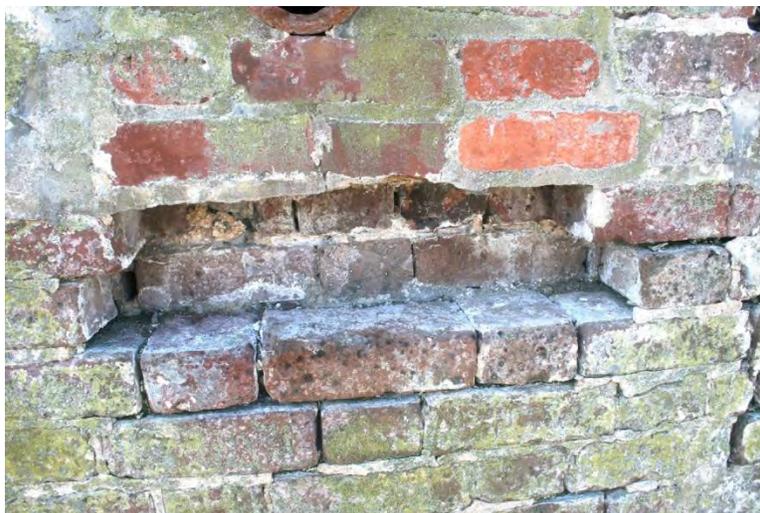
Further detail of the sampling location is given in Figure 16. Two of the bricks in this study (designated East 82 and East 83) were taken from the lower course of darker bricks exhibiting iron spots (base of opening where bricks were removed). The other brick for this study (designated East 81) was of a light color and it was taken from the same area, although this brick was likely placed during installation of the clay pipes.

**Figure 16: Detail of Specimen Location with Original Masonry (Darker bricks, lower photograph) and Repair Masonry (Lighter bricks, upper photograph – possibly from installation of clay drainage pipes during lighthouse service, 1900's)**

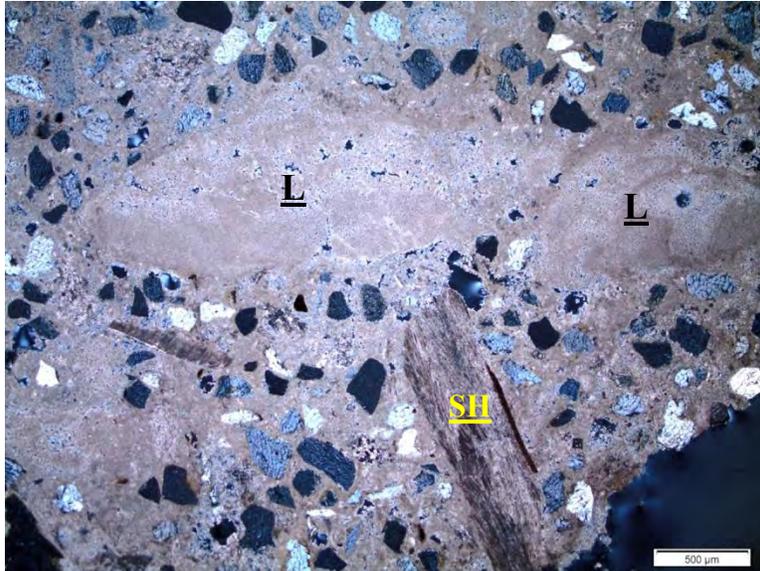
An image of the loose mortar is shown in Figure 21. Notably, the mortar contains oyster shell relics (labeled “SH”) and lime agglomerates (labeled “L”). The other minerals include sand (in various stages of light extinction) and particles suspected as “brick dust”. Brick dust has been used in lime mortars since the Roman Era to strengthen mortars and impart chemical durability.

**Figure 21: Microscopic Image of Loose Mortar**

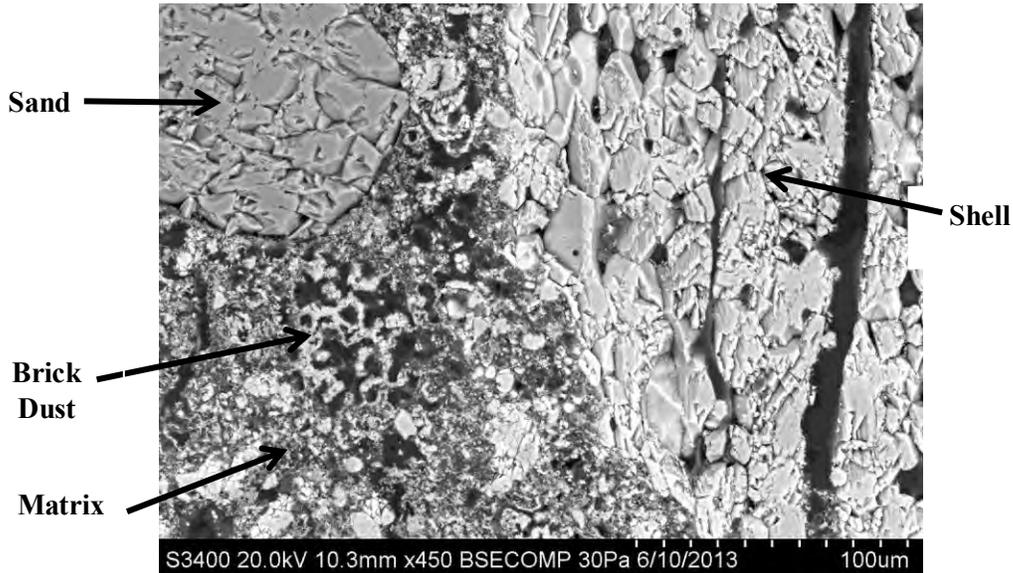
**Figure 24 – SEM Image of the Loose Mortar**

The constituents of this loose mortar suggest that the specimen is a pointing mortar. The evidence includes a significantly lower SiO<sub>2</sub> content than in the 83 mortar (Table 2) suggesting the light sanding (low sand content) of pointing mixes. Further, the bulk density and the porosity of the loose mortar are different than that of the 83 mortar (Table 4) in such a manner as to imply the loose mortar was used for pointing.
