# Forensic Evaluation of Masonry Materials Castle Pinckney, Charleston Harbor, SC

Denis A. Brosnan, Ph.D., P.E.  
Bishop Chaired Professor  
Clemson University  
© 2013, D. A. Brosnan

July 3, 2013

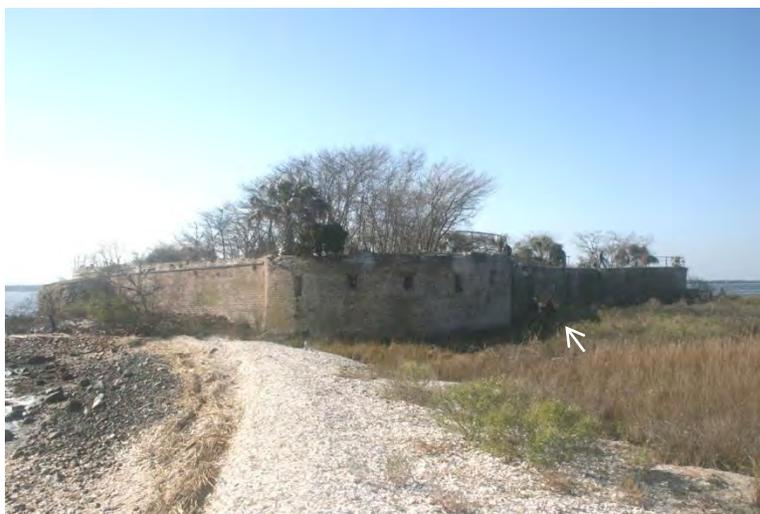
**Figure 7: Right Flank and East Half-Round Bastion with Gorge Wall/Parade (right)**

The East bastion and parade are shown in Figure 7. There were no structures on the parade, but loose bricks were observed in the marsh. The partially buried sally port is barely visible in this photograph (arrow). The exterior walls show residuals from the white pargeting over the masonry (Figure 8). Weirick reports that the white coating was a “lime wash”, and the implication is that it was applied to reduce water intrusion into the masonry as the Castle was repaired prior to the Civil War (reference 4). Water impingement on the masonry at high tide appears as likely in a clock wise direction from South to East. Contemporary sea level is about two feet higher today than that in 1860 (See the base of scarp in Figure 8 where the coating is removed by wave action).

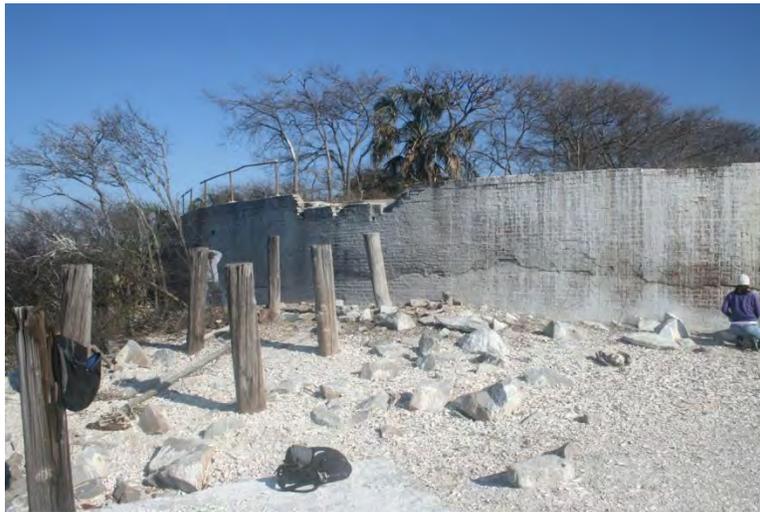
**Figure 9: Remains of Dock on South West Side**

The remains of the 1900's era dock on the Southwest face are shown in Figure 9. This dock can be seen as leading to the top of the wall. The original dock structure is shown in Figure 10, and the suggestion is that the wooden dock is a post-Civil War addition. A stone structure in Figure 10 (arrow) is termed the "stone wharf" in literature, and it is likely part of the original construction of the Castle.

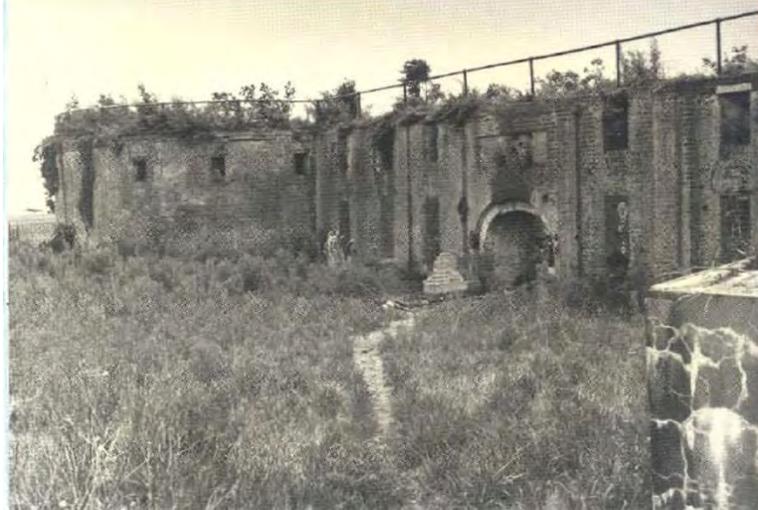
**Figure 13: Sally Port on Gorge Wall (1978, Lewis and Langhorn)**

The interior earthen fill is obvious in Figure 12. It partially obscures the sally port which barely remains passable today due to the fill principally on the interior but also present on the exterior (Figure 7). There was apparently no obstruction of the exterior to the sally port in 1978 (Figure 13).

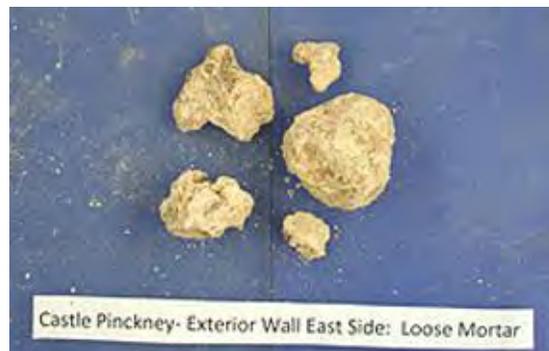
**Figure 17: Loose Mortar Particles As-Received**

The as-received mortars are shown in Figures 17-18. The loose mortar consisted of granules, and it was obtained by collecting the fragments from the sampling location on top of a ledge of bricks (Figure 14). The other mortar specimen labeled as “83” was adherent to a brick specimen confirming that it was an original bedding mortar used when that brick was laid.

The constituents of this loose mortar suggest that the specimen is a pointing mortar. The evidence includes a significantly lower SiO<sub>2</sub> content than in the 83 mortar (Table 2) suggesting the light sanding (low sand content) of pointing mixes. Further, the bulk density and the porosity of the loose mortar are different than that of the 83 mortar (Table 4) in such a manner as to imply the loose mortar was used for pointing.

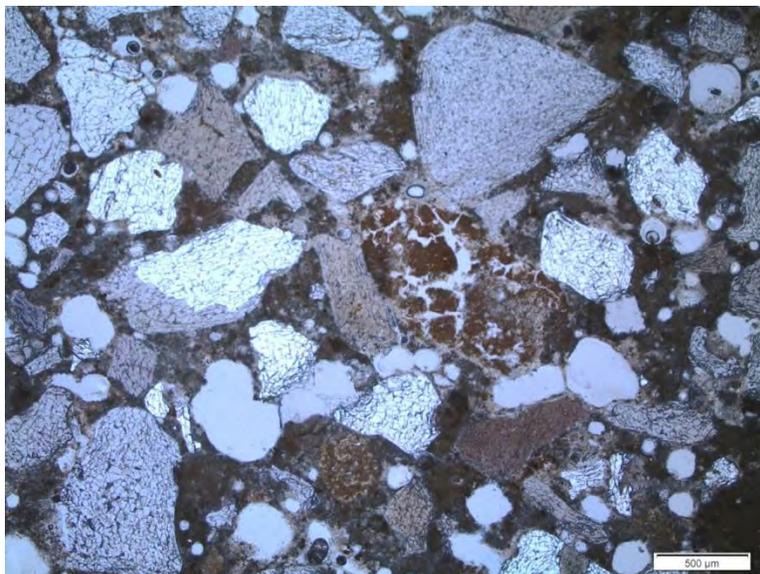
**Figure 22: Petrographic Image of Mortar 83**

A low magnification image of mortar 83 is shown in Figure 22. The quartz sand comprises the angular particles in various degrees of brightness (stages of extinction). The continuous phase around sand grains is comprised of calcium carbonate binder and opaque particles suspected as brick dust.

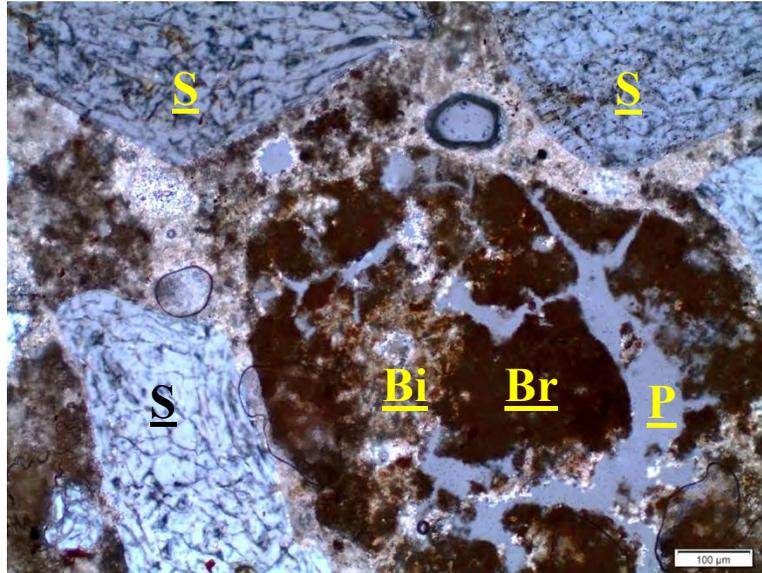
**Figure 23: Petrographic Image of Mortar 83 at High Magnification**

The phases in the mortar 83 matrix are observed at higher magnification in Figure 23. The sand grains (labeled “S”) are located around an agglomerate of opaque particles suspected as

brick dust (labeled “Br”). The calcium carbonate binder phase (“Bi”) is light colored. Continuous blue areas are porosity (“P”).

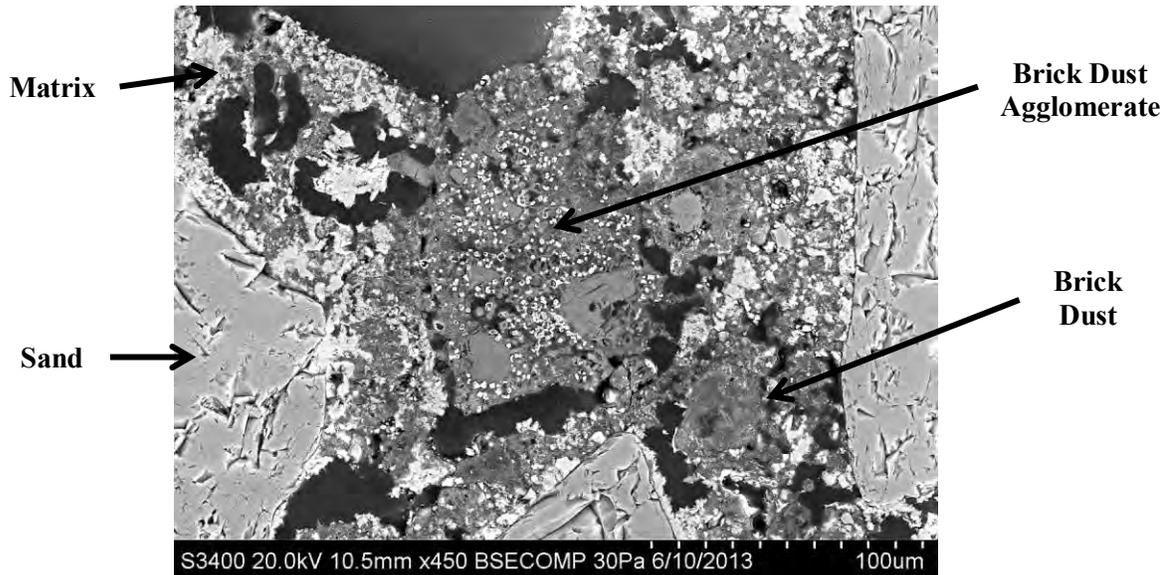
**Figure 25: SEM Image of the 83 Mortar**

The microstructure of the 83 mortar by SEM is shown in Figure 25. One interesting observation is that large shell relics are not found in the mortar (confirming the observations by petrography in Figures 22 and 23). The chemical analyses of artifacts are reported in Table 9 allowing the following observations:

- The analysis of the sand is slightly different in the East 83 mortar than the loose mortar suggesting a different source (East 83 at 98.6-99.3% SiO<sub>2</sub> compared to the loose mortar at 96.6-97.4% SiO<sub>2</sub>). This implies that the mortars could have been made at different time periods using a different source for the sands, i.e. the bedding mortar may be original construction and the loose mortar from a repair.
- The ratio of Al<sub>2</sub>O<sub>3</sub> to SiO<sub>2</sub> in brick dust in the East 83 mortar at 0.12 compares favorably to the value for brick dust in the loose mortar of 0.13. This simply says that similar brick dust as from local bricks was used in both specimens.
- The white relics represent the matrix/continuum of the mortar and represent the carbonate binder with small shell fragments and fine sand.

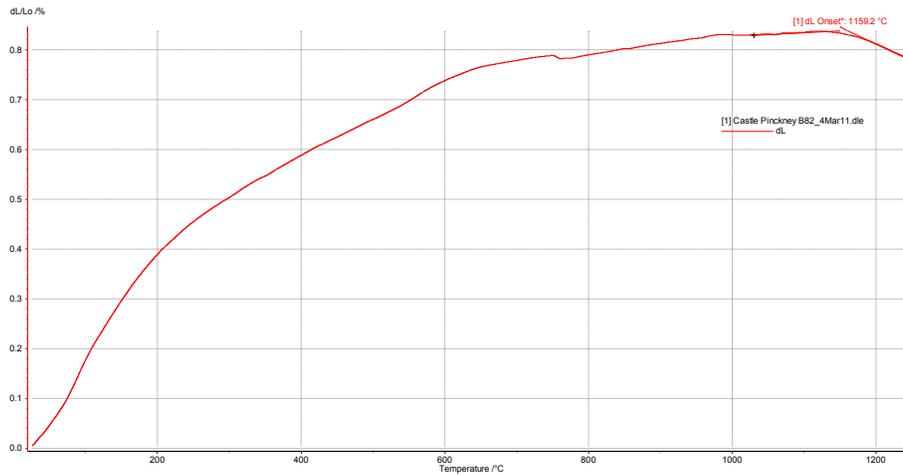
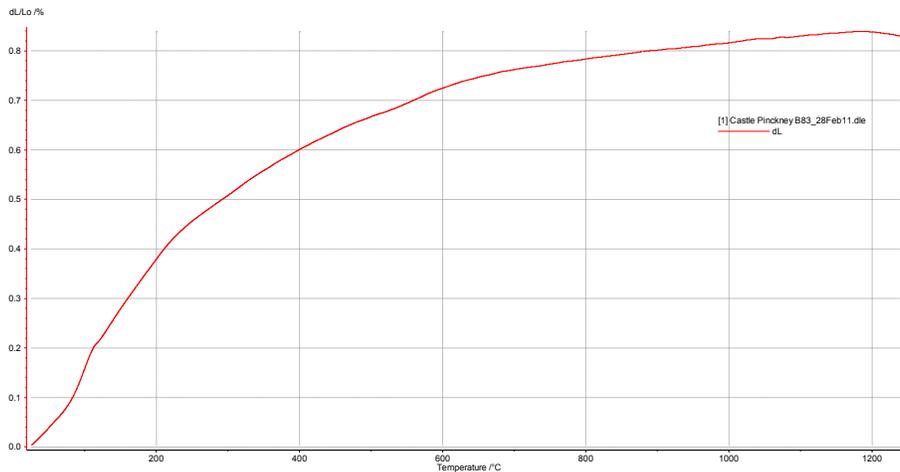
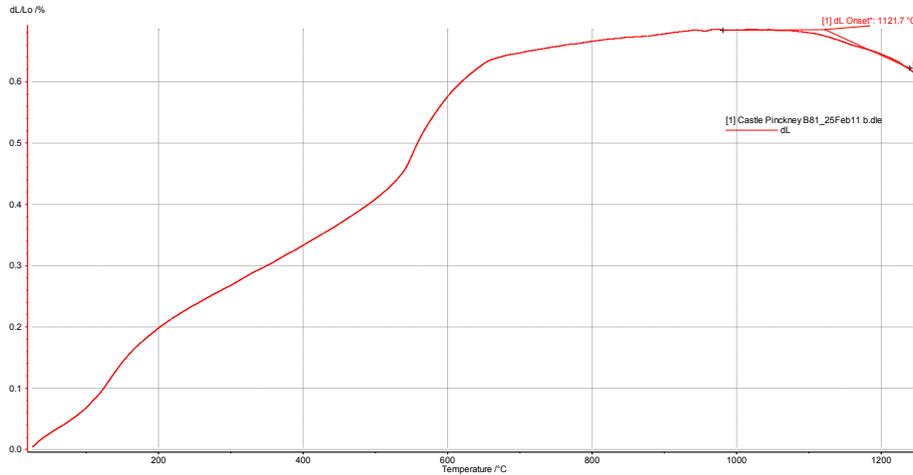
Thermal expansion of bricks was determined by dilatometry as shown in Figures 35-37 with the results summarized in Table 15. For restoration purposes, the thermal expansion behavior near ambient temperature is important. The measurements were continued to elevated temperatures so that the firing temperature could be estimated by the temperature of initial deformation<sup>21</sup>.

The thermal expansions in the low temperature region of interest (for repairs) are extremely high reflecting the crystalline silica content of the bricks. The high values of the thermal expansion coefficient are particularly affected by the cristobalite content due to its polymorphic inversion at about 180°C. Values this high are exhibited by silica refractories produced from nearly 100% quartzite (ganister).

the historic bricks. Failure to match thermal expansion coefficient can result in long-term degradation of the historic masonry.

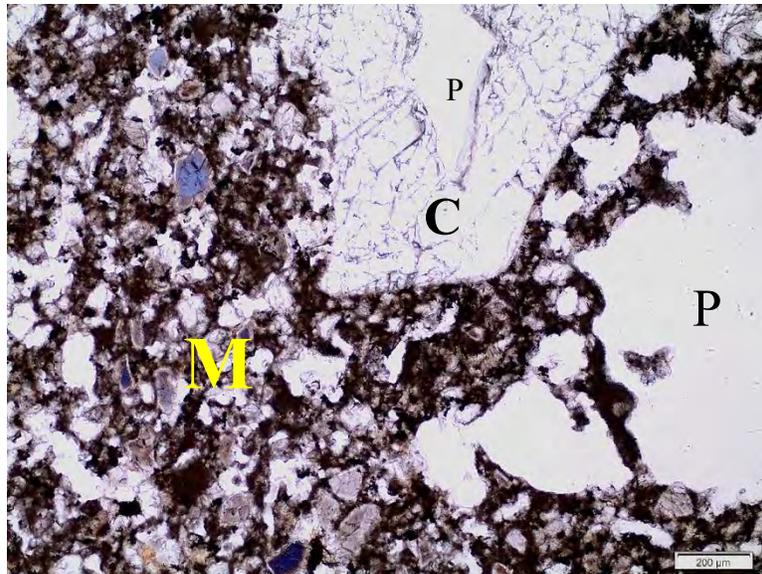
**Figure 39: Brick East 82 (See chert “C”)**

Similar optical microscopy/petrography techniques were used with bricks East 82 and East 83 as with the mortars (reported above). A low magnification photomicrograph of brick East 82 is shown in Figure 39. The most interesting feature is the chert nodule (labeled “C”), an artifact found frequently in Charleston historic bricks.

The East 82 brick of Figure 39 also shows large pores and a void in the chert nodule (labeled “P”). The matrix or continuous phase (labeled “M”) is composed of clay, fine silica crystals, pores, and other minerals. The East 83 brick of Figure 40 exhibits a similar microstructure, although no chert nodules are seen in the field shown. There was no microscopic characterization of the East 81 brick.
